## GA352.59

### Assembly/disassembly recommendations

<b>FORD:</b> Mondeo II (2000, 2000 FL and 2005), <b>JAGUAR:</b> Transit 2000 X-Type and X-Type FL	<b>ENGINES</b> 2.2 TDCi, 2.0 Di, 2.0 TDDi, 2.0 TDdi, 2.0TDCi, 2.0 TDci, 2.0 D, 2.2 D	<b>OE reference</b> C2S27002, 1201181
---	---	---

### IDENTIFICATION OF BELT TENSIONER ROLLER GA352.59

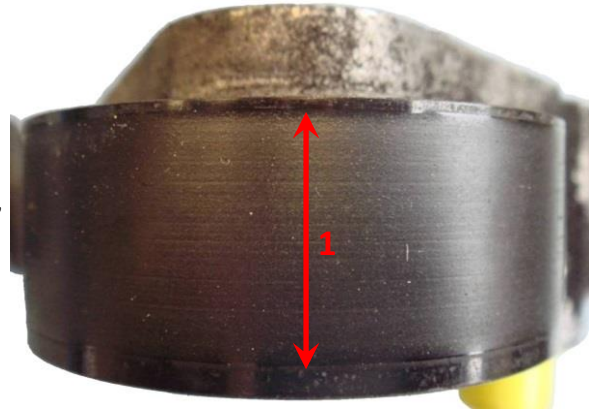
A damaged hydraulic cylinder is one example of what may occur as a result of incorrectly tightening the clamping bolt of the roller before tensioning the assembly.

**Correct operation of the hydraulic damper depends on the orientation in which it is installed. The joint marked with the traceability code must be fixed to the roller assembly.**

This is caused by failing to follow installation procedures, in particular the tightening torque, and the use of incorrect tools.
