GA354.12/GB-07/2022

# GA354.12

## Assembly/disassembly recommendations

## IDENTIFICATION OF BELT TENSIONER ROLLER GA354.12

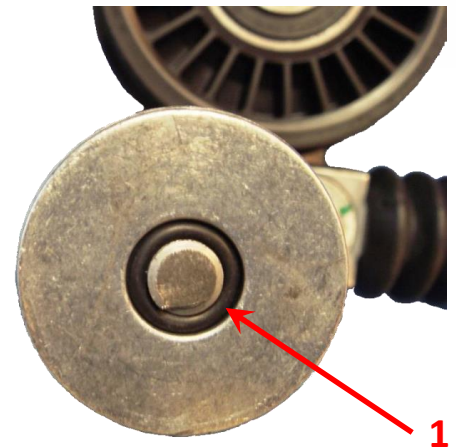
The pivot bolt can snap if it has not been tightened sufficiently (Fig1). Fatigue will have been caused in the bolt by the back-and-forth motion of the roller due to it no longer being held firmly against the engine. This means the bolt will have been subjected to shear loading instead of tensile loading.

Specified tightening torque: **25 N.m**

Failures with GA354.12 are often caused by a faulty overrunning alternator pulley. Overrunning alternator pulleys should be checked or replaced at the same time as the tensioner roller assembly is replaced.
