GA355.16/GB-07/2022

Assembly/disassembly recommendations

IDENTIFICATION OF TENSIONER ROLLER GA355.16

COMMON FAILURES INVOLVING ROLLER GA355.16

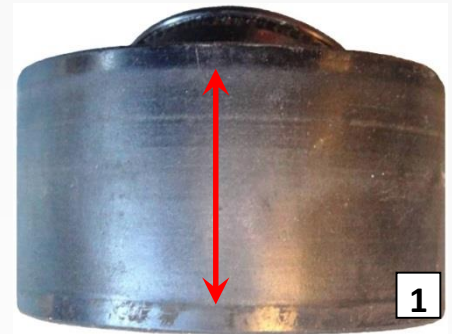
When worn or seized the overrunning alternator pulley does not disengage correctly, this means the alternator can't free wheel when needed. This generates an up and down snatching motion on the belt.

GA355.16 is not designed to absorb the violent shocks caused by the belt, this allows the belt to become incorrectly tensioned allowing it to slip on the rollers (FIG 1).

The slipping belt creates heat on the outer diameter of the tensioner roller pulley. This causes a rise in temperature inside the pulley, causing it to fail.

Failures with GA355.16 are often caused by a faulty overrunning alternator pulley. Overrunning alternator pulleys should be checked or replaced at the same time as the tensioner roller assembly is replaced.

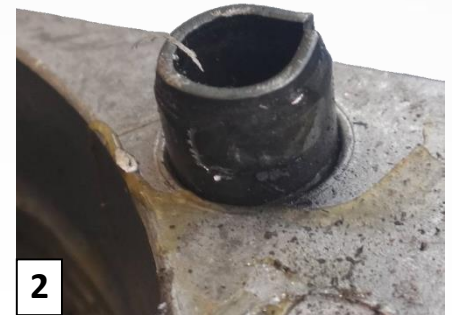
Another sign of an overrunning alternator pulley failure is the tensioner roller assembly stop shows traces of impact and is generally damaged normally bent. This failure is associated with excessively large roller displacement (Fig 2).
