# GA354.12

## Assembly/disassembly recommendations

### IDENTIFICATION OF BELT TENSIONER ROLLER GA354.12

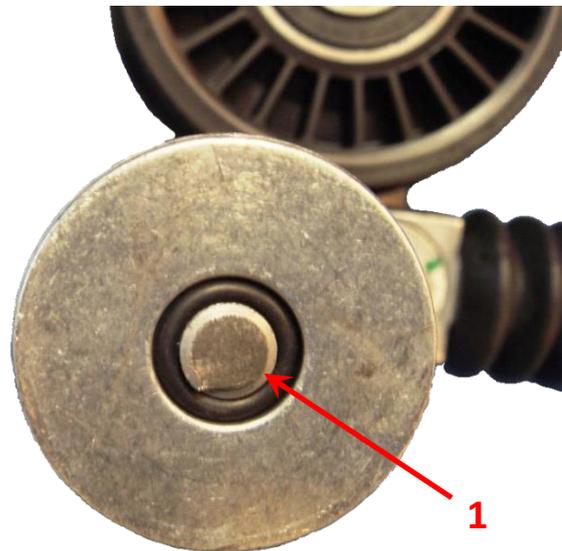
The pivot bolt can snap if it has not been tightened sufficiently (**Fig1**). Fatigue will have been caused in the bolt by the back-and-forth motion of the roller due to it no longer being held firmly against the engine. This means the bolt will have been subjected to shear loading instead of tensile loading.

Specified tightening torque: **25 N.m**

Failures with GA354.12 are often caused by a faulty overrunning alternator pulley. Overrunning alternator pulleys should be checked or replaced at the same time as the tensioner roller assembly is replaced.
