## GA359.70

### Assembly/disassembly recommendations

### IDENTIFICATION OF ACCESSORY BELT TENSIONER ROLLER

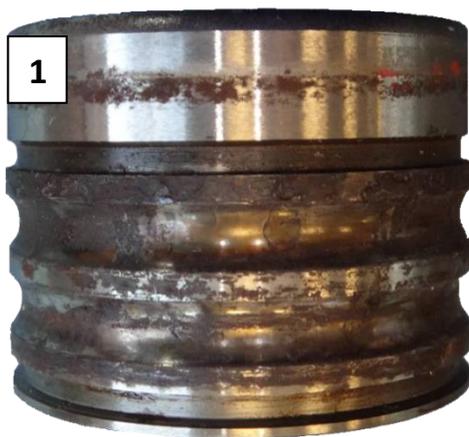
Incorrect fitment normally involves the failure to install the plastic cap supplied with the roller.

Once the roller has been fitted to the engine of the vehicle, it is essential that the cap which is supplied together with the roller is fitted in the centre of the roller. The cap prevents foreign materials such as water and dust from entering the bearing. Without the cap fitted water and dust is likely to penetrate into the bearing, this will degrade the lubricating properties of the grease, causing the bearing tracks (**Fig1**) and rolling elements to corrode and force the lubricant out the bearing (**Fig 2**).

To ensure a tight seal, it is very important to "snap" the plastic cap onto the roller after the roller is fitted and adjusted (**Fig 3**). Without the cap being fitted or with the cap incorrectly fitted, degradation of the bearing will soon occur causing running noise during operation.

Always make sure that the plastic cap is in place, in order to ensure that the roller is tightly sealed.
