GA357.24

Disassembly/assembly recommendations

IDENTIFICATION OF ACCESSORY BELT TENSIONER ROLLER GA357.24

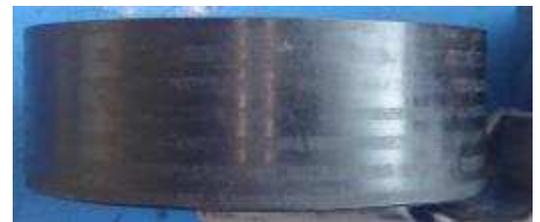
Pulley diameter erosion:

If the belt becomes incorrectly tensioned and moves on the pulley roller, and becomes misaligned. When this happens the polyamide part of the pulley becomes marked and damaged , in some cases the edge of the pulley wears. This wear may allow the belt to slide of the pulley in some situations.

Marks on the pulley

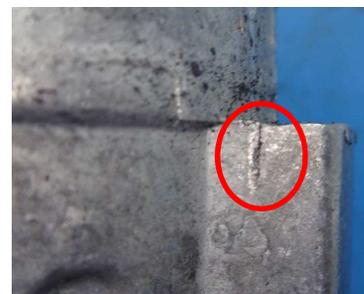
Marks on the stop

Marks on the stops show us the tensioner arm has been bouncing back and forth off the tensioner stops. When the tensioner is working correctly, the tensioner arm operates in between the two stops but never touches them .

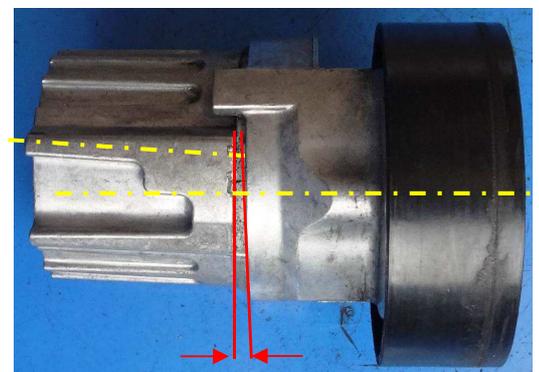
Worn central axis

A worn axis caused by belt misalignment, means the tensioner bends in the middle causing further belt misalignment.

Failures with GA357.24 are often caused by a faulty overrunning alternator pulley. Overrunning alternator pulleys should be checked or replaced at the same time as the tensioner roller assembly is replaced.
Failure of the accessory drive system can cause the vehicle to stop running , in severe cases the accessory belt enters the timing system causing major damage.
