KF155.70U

Removal / Installation recommendations

IDENTIFICATION OF BRAKE DISC HUB KIT KF155.70U

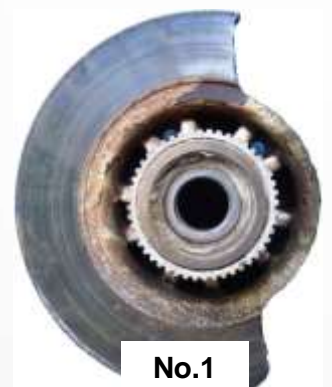
Brake system malfunction.

This occurs when the calipers seize or the handbrake system locks up. The disc remains locked and as a result the disc hub is subjected to a high increase in temperature. The brake disc inevitably fractures and breaks (no. 1).

The vehicle should not be driven until repairs to the braking system have been made.

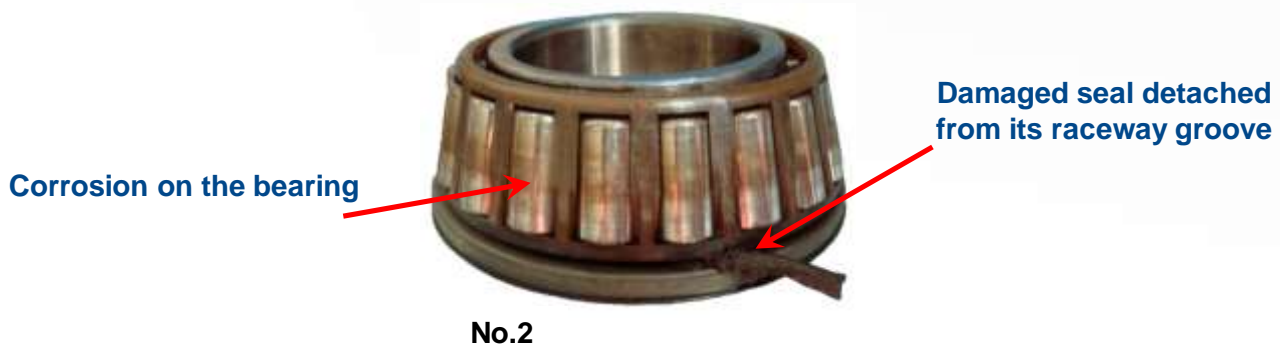
Incorrect installation of the disc hub on to the stub axle.

Incorrect fitment of the disc hub assembly when mounting it on to the stub axle can lead to the disc hub assembly being fitted askew, this damages the inner rings of the bearing and prevents correct adjustment, this results in a rapid failure of the disc hub.

Incorrect installation of the inner ring, which detaches from its raceway groove, causes the bearing to open. The open bearing then causes serious damage to the seal, this then allows contaminants such as water to enter the bearing (no. 2). This results in rust damage causing the bearing to become noisy and greatly shorten its service life (no. 2).

This failure is irreversible, the bearing and disc have to be replaced as a complete unit KF155.70U
