KB659.27

Assembly recommendations

<p>Citroën: Jumper (I, II, III), Relay (II, III) Fiat: Ducato (I, II) Peugeot: Boxer (I, II, III)</p>	<p>OE Reference: 1610531680 5031-78 9405031789</p>
--	--

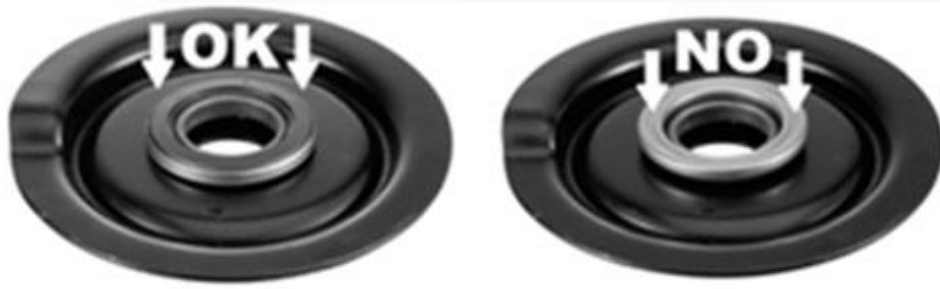
Observe the direction of the stop: metallic side not visible

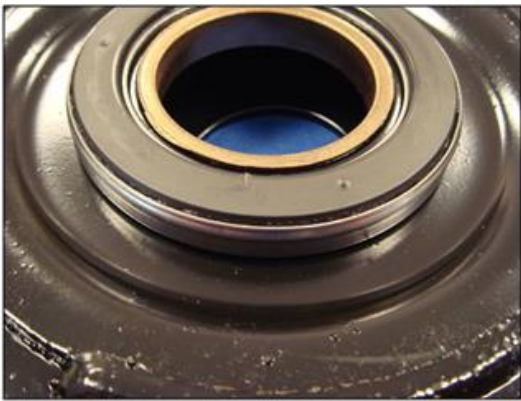
Correct assembly of the stop

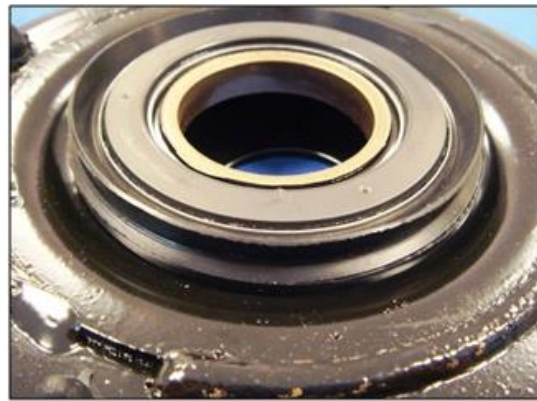
Mounting the seal on the stop

Observe the direction of the seal: sealing lip on the filter block side

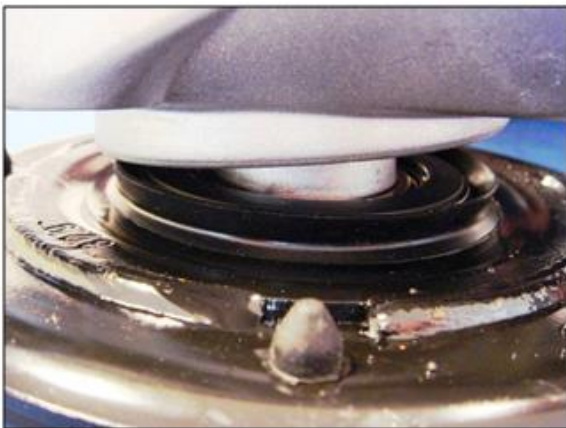
Fitting the filter block in the holder

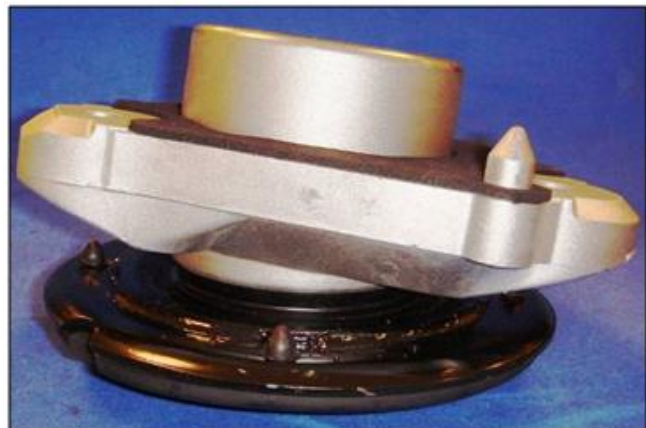
Appearance of the final assembly

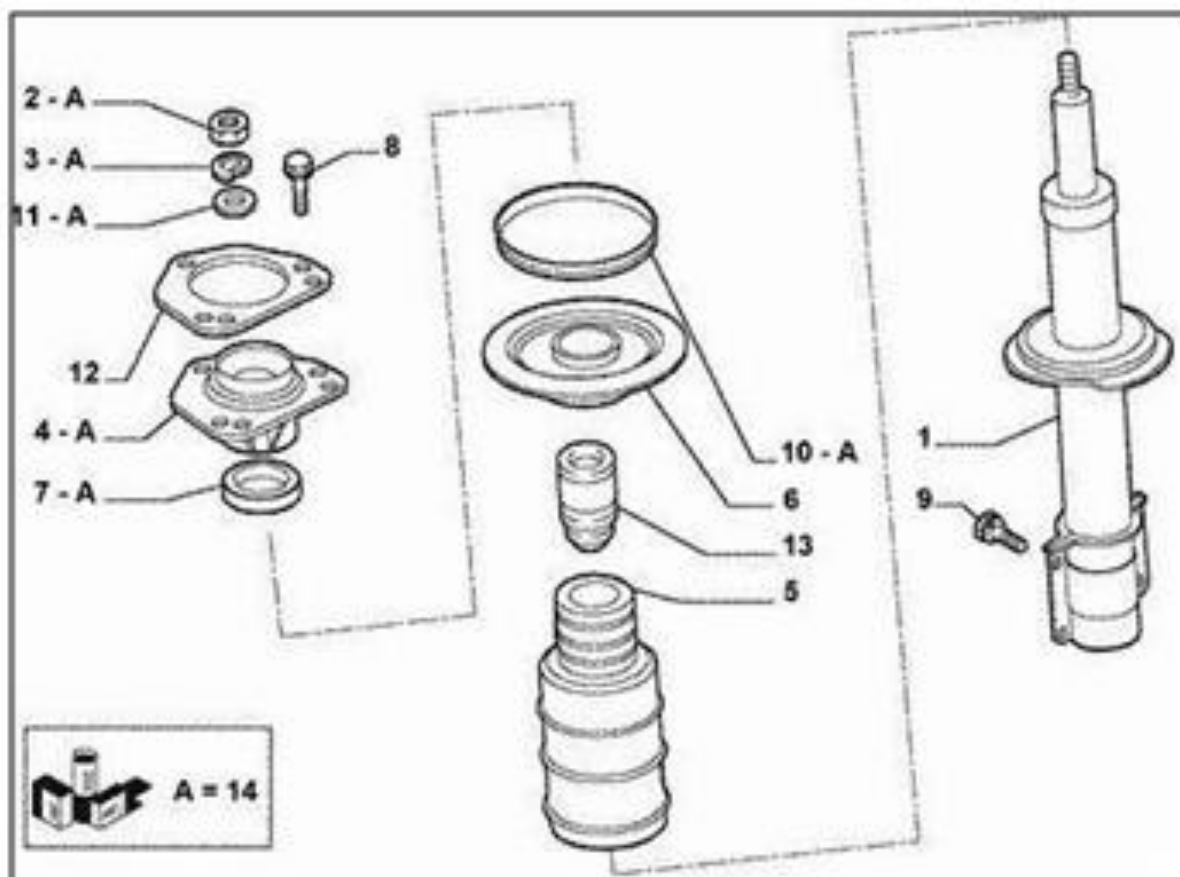
Assembly layout of the parts
