KF155.70U/EN/05/2022

KF155.70 U

Removal / Installation recommendations

IDENTIFICATION OF BRAKE DISC HUB KIT KF155.70U

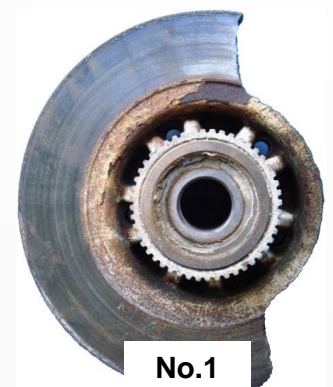
Brake system malfunction.

This occurs when the calipers seize or the handbrake system locks up. The disc remains locked and as a result the disc hub is subjected to a high increase in temperature. The brake disc inevitably fractures and breaks (no. 1).

The vehicle should not be driven until repairs to the braking system have been made.

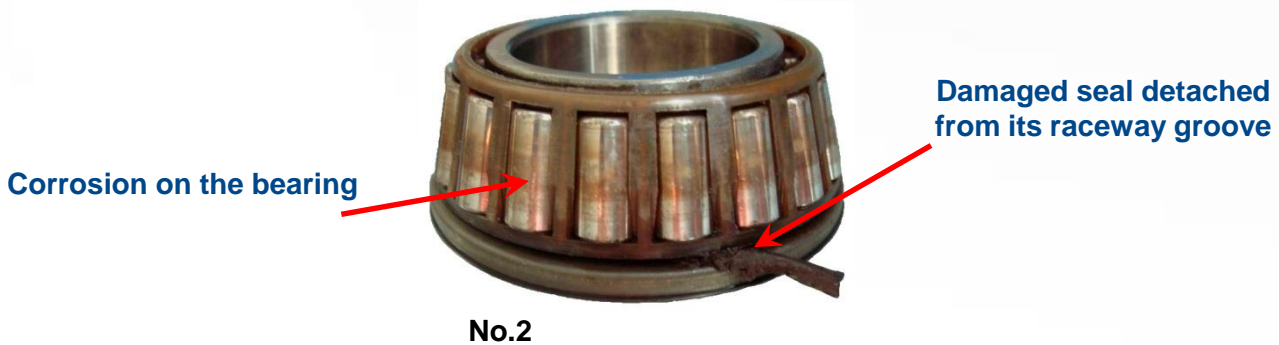
Incorrect installation of the disc hub on to the stub axle.

Incorrect fitment of the disc hub assembly when mounting it on to the stub axle can lead to the disc hub assembly being fitted askew, this damages the inner rings of the bearing and prevents correct adjustment, this results in a rapid failure of the disc hub.

Incorrect installation of the inner ring, which detaches from its raceway groove, causes the bearing to open. The open bearing then causes serious damage to the seal, this then allows contaminants such as water to enter the bearing (no. 2). This results in rust damage causing the bearing to become noisy and greatly shorten its service life (no. 2).

This failure is irreversible, the bearing and disc have to be replaced as a complete unit KF155.70U
