WHEEL BEARING
RANGE

DIAGNOSTIC EXPERT

ANALYSIS & RECOMMENDATIONS

NTN **SNR**

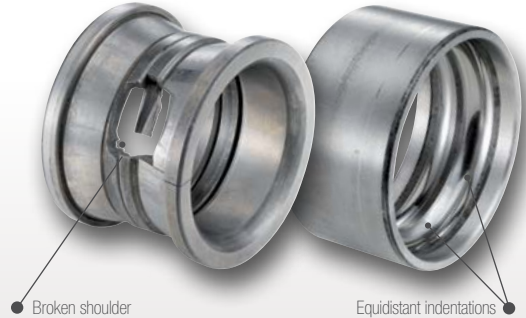
1

INDENTATIONS OR BREAKAGE OF THE SHOULDER DUE TO A FAULTY FITTING

- Presence of indentations located on the edge of the track and often seen over the complete circumference of the ring
- The indentations are in line with the position of the rolling elements
- Damaged or broken shoulder
- A slapping noise to the assembly

- The bearing was off-centre when fitted
- The bearing fitting was incorrect
- The bearing was dropped onto a hard surface
- The bearing tightening load was transferred through the rolling elements

- Apply the load on the right ring, the fitting force should not go through the rolling elements
- Follow the general recommendations related to fitting

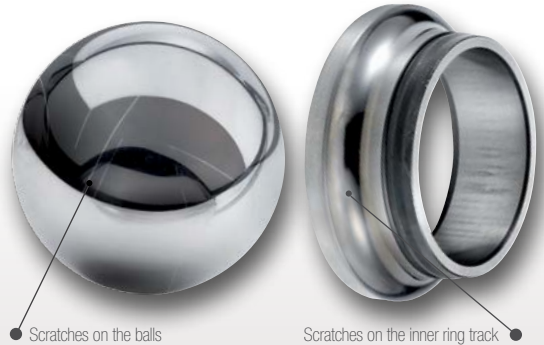
2

SCRATCHES ON SUCCESSIVE BALLS FROM AN UNTIGHTENED DRIVESHAFT

- Damage with circular grooves deforming the surface of the balls
- Grooved scratches similar to "petanque balls"
- Matching damage on the bearing tracks

- The vehicle was moved without the driveshaft or hub nut in place (such as when being serviced)
- Damage on the balls from contact and rolling on the inner edge of the track, due to a gap between the inner races

- Avoid moving any vehicle when the driveshaft nut is not tight

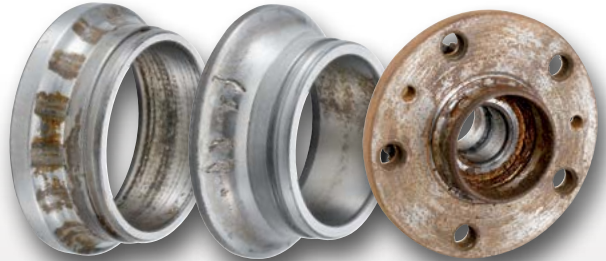
3

CONSECUTIVE FLAKING DUE TO A FAULTY SEAL

- Local or generalised oxidation of the bearing
- Reddish or black staining more or less widely distributed on the bearing
- Pitting has damaged the surface to a variable extent

- Insufficient or incorrect sealing for the installation
- Damage to the bearing seal during maintenance
- Lack/non replacement of the cap

- Never dis-assemble a sealed bearing, damage is inevitable
- Avoid spraying with liquids
- Follow the general recommendations related to fitting

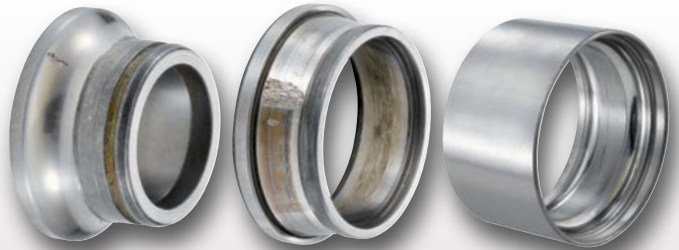
4 FATIGUE SPALLING

- Track surface damaged from flaking

- Faulty fitting
- Faulty (deformed) mating components

- Follow the general recommendations related to fitting

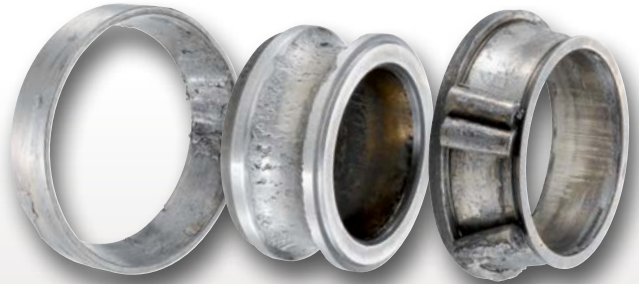
5

SEIZURE / OVERHEATING / FAULTY LUBRICATION

- The bearing has shallow metal surface damage on the tracks
- The bearing components are welded
- Components are coloured

- Lack of or incorrect bearing lubrication
- Micro-welding between bearing components
- Grease is contaminated due to pollution ingress

- Watch out for any possible loss of grease which appears unusual
- Follow the general recommendations related to fitting

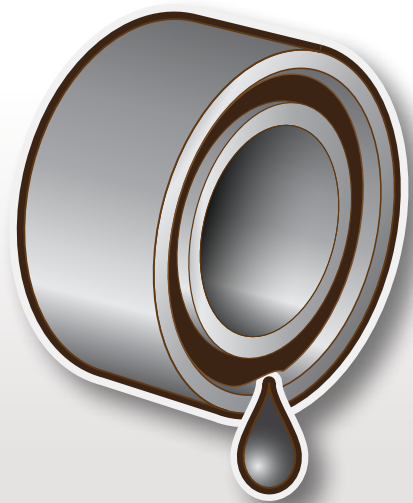
6 LOSS OF GREASE

- The mechanic notes an escape of grease from the bearing seals

- A large rise in bearing temperature causing deterioration of the grease
- Entry of water contaminates the grease

- Check that there is not an overheating problem (e.g. a sticking hand brake)
- Check the bearing seal condition

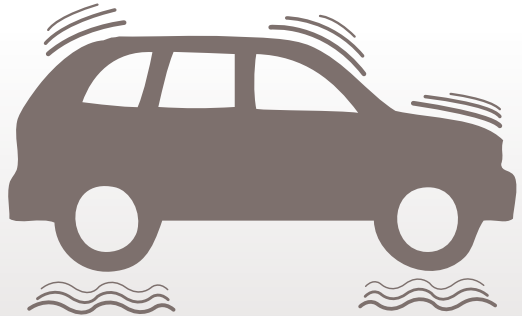
7 VIBRATION

- On the road, the driver senses vibrations in the driving compartment

- Bad condition of the mating parts (a balance problem)
- Incorrect tightening of the bearing

- Check the wheel balance
- Follow the general recommendations related to fitting of the wheel bearing or torque

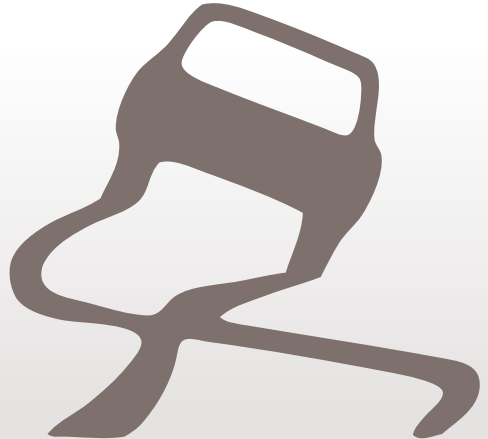
8

DIFFICULTY IN STEERING STRAIGHT

- Driven in a straight line the vehicle tends to drift to the left or to the right

- Incorrect adjustment of the drivetrain
- Steering system stiffness: worn ball joints
- Incorrect tightening of the bearing

- Check the axle adjustments
- Replace the ball joints

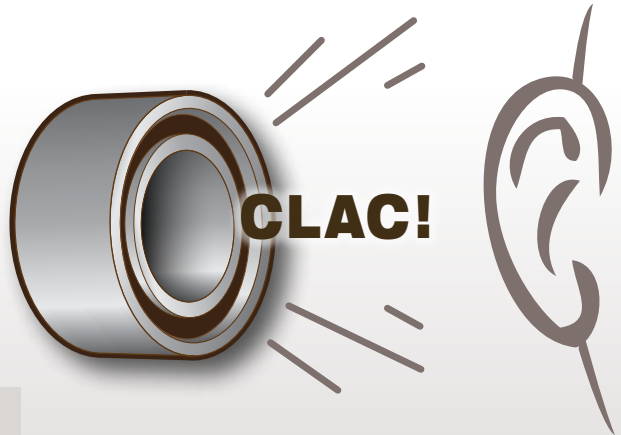
9

CLACKING / NOISE

- A loud noise from the front axle (when parking)

- A small movement of the bearing in the stub axle housing

- Check the dimensions and condition of the stub axle housing

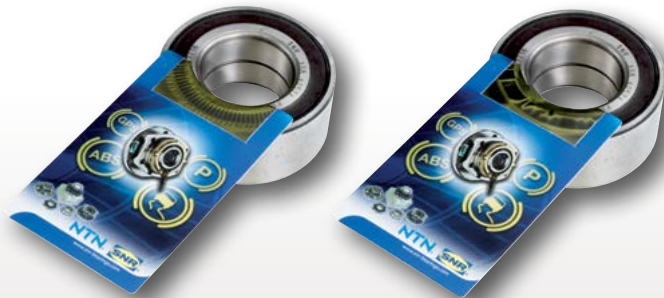
10 ABS FAULTS

- The ABS warning panel light comes on or remains on

- Computer failure
- Sensor failure
- Connection problem
- Encoder deteriorated
- Bearing fitted the wrong way round

- Check the encoder and sensor are clean
- Never bring a magnet near to the encoder
- To fit bearings of first generation in the right way, make sure to use the ASB® test card
- Use of the NTN-SNR card tester is essential
