TIMING AND ACCESSORY Ranges

Diagnostic Expert **Analysis & Recommendations**

MAJOR CAUSES OF TIMING BELT FAILURES:

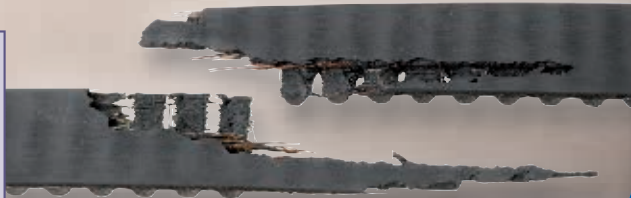
1 UNEVEN BREAKAGE

- The belt is torn diagonally

- Over tightened belt
- Jammed by another part
- Contamination solid or liquid

- Observe the general recommendations relating to the assembly

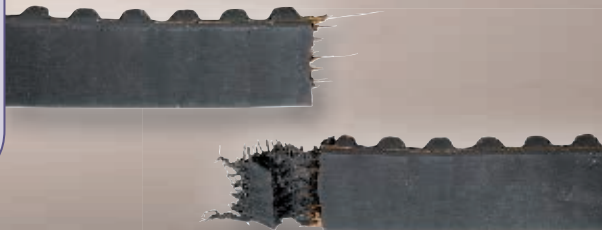
2 A CLEAN BREAK

- The belt is ripped apart

- Defective material
- Use of unsuitable tools
- The belt was twisted
- Contamination solid or liquid

- Observe the general recommendations relating to the assembly

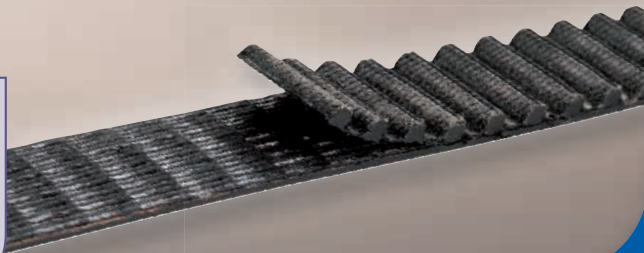
3 DETACHED OR SEPARATION OF THE BELT TEETH

- Detached or separation of the belt teeth

- Low belt tension – loss of tension
- An obstruction by an unknown component
- Contamination solid or liquid
- Incorrect tools used during fitting

- Check the mounting of the tensioner
- Eliminate any leakages
- Observe the general recommendations relating to the assembly

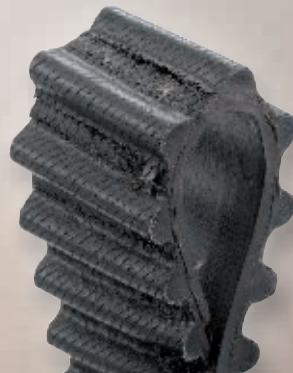
5 SPLIT TEETH

- Splits at the base of the teeth

- Belt is under tensioned
- An obstruction by an unknown component
- Incorrect tools used during fitting

- Observe the general recommendations relating to the assembly

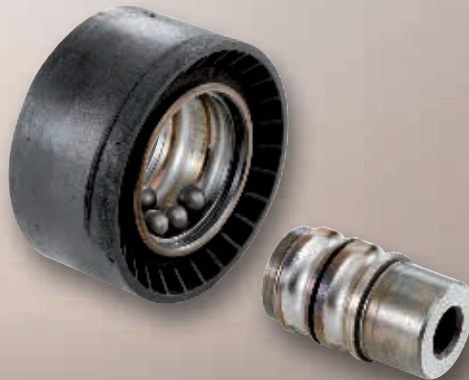
12 OVERHEATED ROLLER

- The roller is disassembled and miscoloured

- Excessive tension
- Obstruction by external parts (heat has spread from the back of the belt)

- Observe the general recommendations relating to the assembly

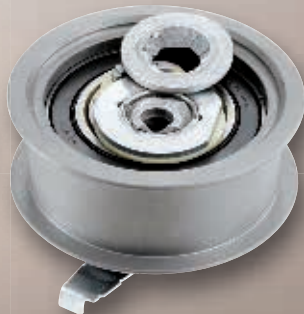
13 MOUNTING BRACKET BROKEN (OR REDUCED OPERATING CLEARANCE)

- Broken centre of the roller

- Lubricated screw
- Over tightening that has caused a breakage of the support surface

- Observe the general recommendations relating to the assembly

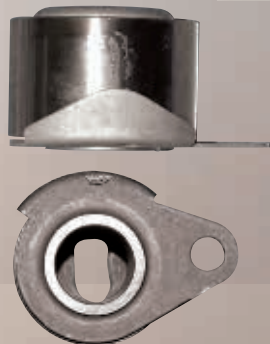
15 THE ROLLER IS NOT POSITIONED CORRECTLY

- Tensioner indexing is not correct
- Circular marking
- Purple discolouration
- Seizure of the roller and friction on the belt

- Incorrect tension, bad index position on the engine housing
- Crushed roller plate by contact from centering on the engine

- Change the belt
- Observe the general recommendations relating to the assembly

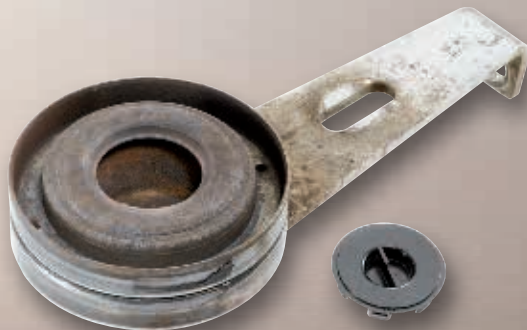
16 SEIZURE AND / OR UNUSUAL NOISE

- Extensive corrosion

- Omission of the protection cap when fitting, allowing water and dust to enter the bearing
- The grease is degraded by the contamination and cannot correctly lubricate the internal elements

- Always fit the cap provided for the roller
- Check the correct position of deflectors

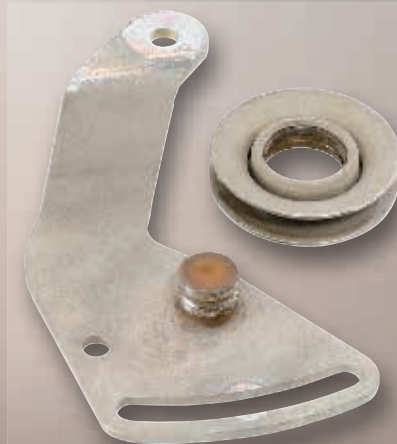
17 CORROSION OF THE TRACK

- Significant deposits of pollution

- The grease is degraded by the contamination and cannot correctly lubricate the internal elements

- Avoid using high pressure washers on the engine
- Check the correct installation of deflectors and engine casings

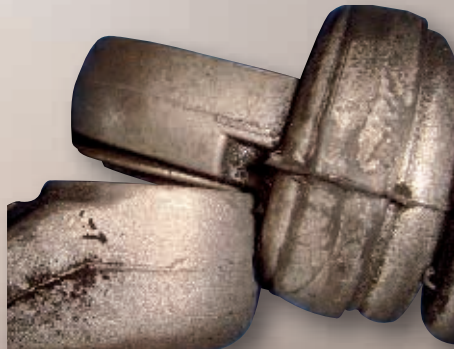
18 DAMAGED MOUNTING BRACKET

- Distortion or absence of the mounting arm

- Incorrect tightening or loosening of the joint

- Tighten the screw to the recommended torque
- Lubricate the unthreaded shank of the screw but not the threads

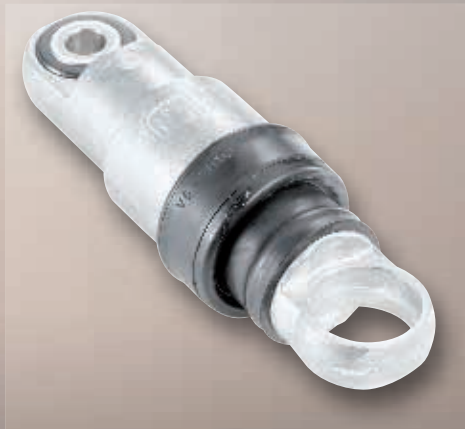
19 OIL LEAKS

- Leaks from the actuator

- Mishandling /shocks when fitting the part
- Using an unspecified actuator

- Use the correct length of belt
- Observe the general recommendations relating to the assembly

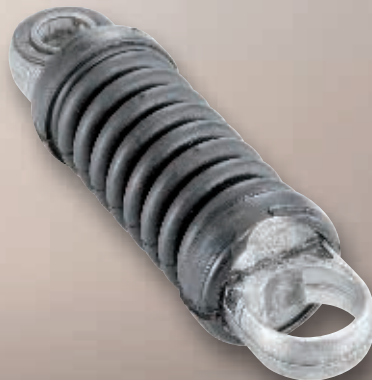
20 MISALIGNMENT AND FAILURE OF THE ACTUATOR

- Damaged actuator

- Washer not fitted during fitting, leading to misalignment of the actuator and early failure
- Under or over tightening of the joint

- Do not forget to refit the washer

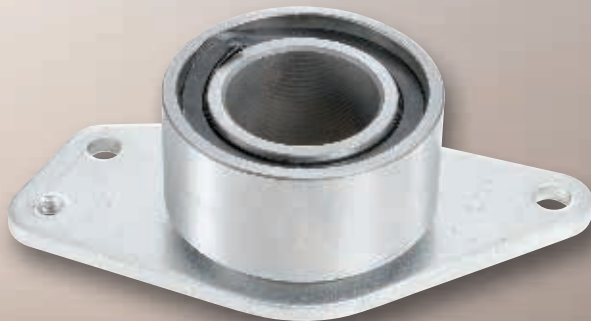
21 DAMAGED SEAL

- Seal on the roller is damaged

- Mishandling /shocks when fitting the part

- Fit all parts supplied with the roller
- Replace the damaged roller with a brand new roller

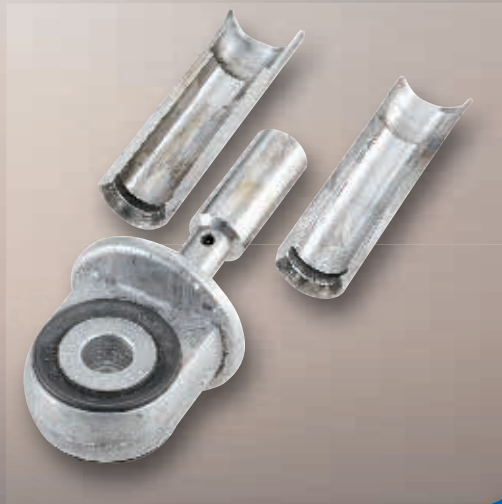
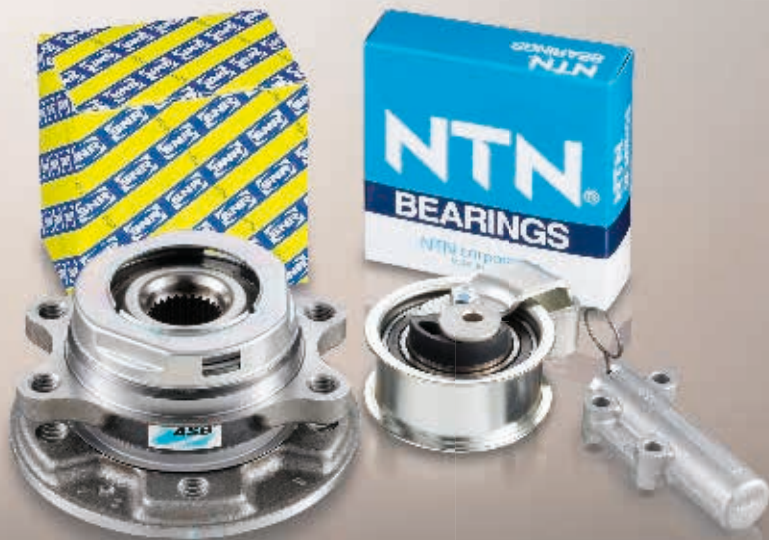
22 UNUSUAL VIBRATION FROM THE ROLLER ARM

- Spring broken
- Premature wear of the roller

- Length of the belt is incorrect
- Obstruction by external parts

- Check and replace as required, the free wheel pulley and the alternator pulley damper
