KB659.26/KB659.27

Assembly recommendations

CITROËN: Jumper (I, II, III), Relay (II, III)	OE reference
FIAT: Ducato (I, II)	1610531680
PEUGEOT: Boxer (I, II, III)	5031-78
	9405031789

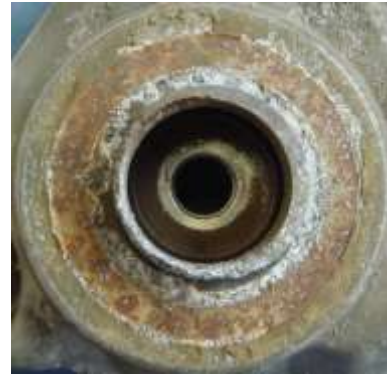
PREMATURE FAILURE OF THE STOP

Improper installation of the kit.

Failure is linked to some kind of pollution being introduced; it is important to change all the parts and especially to follow the reassembly instructions correctly.

This failure is a result of an inverse assembly of the two stops and two joints (see assembly process).

- Observe the direction of the stop: dark side of the stop to the filter block side.
- Observe the direction of the seal: sealing lip on the filter block side.
- Careful not to deform the joints during assembly and do not overly lubricate the two sets.

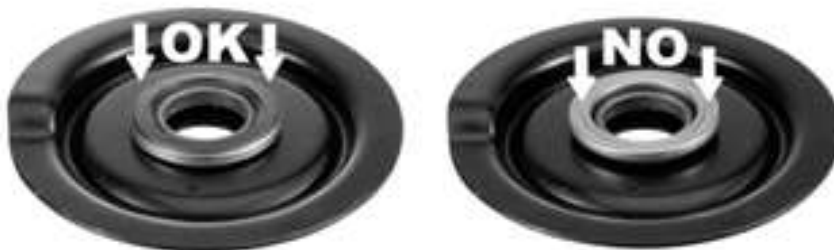
Observe the direction of the stop: metallic side not visible

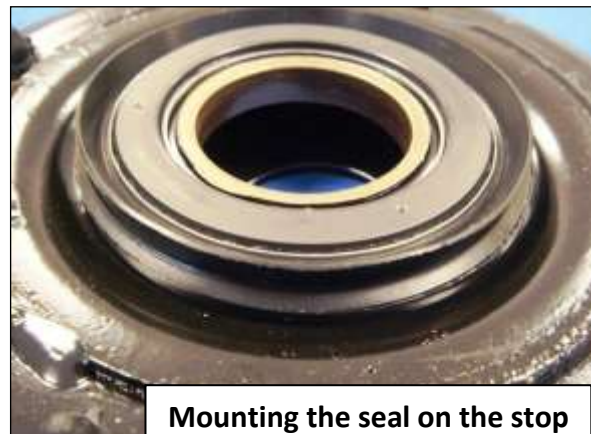
Mounting the seal on the stop

Observe the direction of the seal: sealing lip on the filter block side
