KF155.70U

Assembly/disassembly recommendations

NISSAN:	Primastar, Primastar FL,
OPEL:	Vivaro, Vivaro FL
RENAULT:	Trafic II, Trafic II FL
VAUXHALL:	Vivaro, Vivaro FL

IDENTIFICATION OF BRAKE DISC HUB KIT

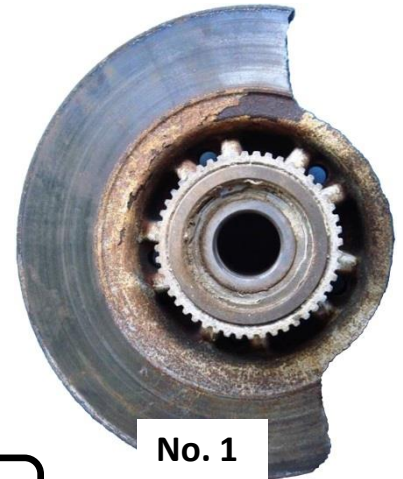
Brake system malfunction.

This occurs when the calipers seize or the handbrake system locks up.

The disc remains locked and as a result the disc hub is subjected to a high increase in temperature. The brake disc inevitably fractures and breaks **(no. 1)**.

The vehicle should not be driven until repairs to the braking system have been made.

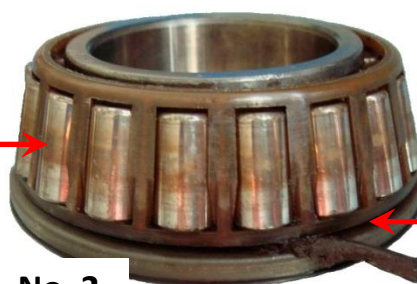
No. 2

Incorrect installation of the disc hub on to the stub axle.

Incorrect fitment of the disc hub assembly when mounting it on to the stub axle can lead to the disc hub assembly being fitted askew, this damages the inner rings of the bearing and prevents correct adjustment, this results in a rapid failure of the disc hub. Incorrect installation of the inner ring, which detaches from its raceway groove, causes the bearing to open. The open bearing then causes serious damage to the seal, this then allows contaminants such as water to enter the bearing **(no. 2)**. This results in rust damage causing the bearing to become noisy and greatly shorten its service life **(no. 2)**.

Corrosion on the bearing

Damaged seal detached from its raceway groove

This failure is irreversible, the bearing and disc have to be replaced as a complete unit KF155.70U
