KB950.00

Removal / Installation recommendations

BMW: M3 (E30, E36), Série 3 (E30,

IDENTIFICATION OF SUSPENSION BEARING KIT KB950.00

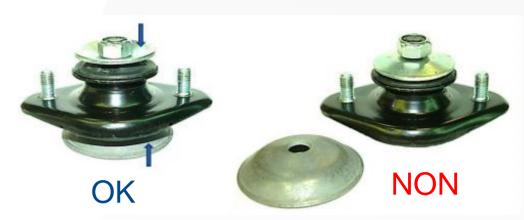
COMMON PROBLEMS: THE RUBBER ISOLATOR BUSH SEPERATING FROM THE METAL **SUPPORT**

Incorrect assembly of the kits components.

This failure is common when the shock absorber strut sub assembly is not correctly assembled ie, parts

fitted the wrong way around or totally missed out.

- When replacing the insulator, make sure the two mounting cups (upper and lower) are retained as they are needed to reassemble the strut top mounting.
- Make sure the cups and reinstalled the correct way around.

Do not change the installation orientation of the upper mounting cup (dished upwards) Do not forget to re-install the lower mounting cup in its correct installation orientation (dished downwards).
