# R154.13

## Disassembly / Assembly recommendations

### IDENTIFICATION OF WHEEL KIT R154.13

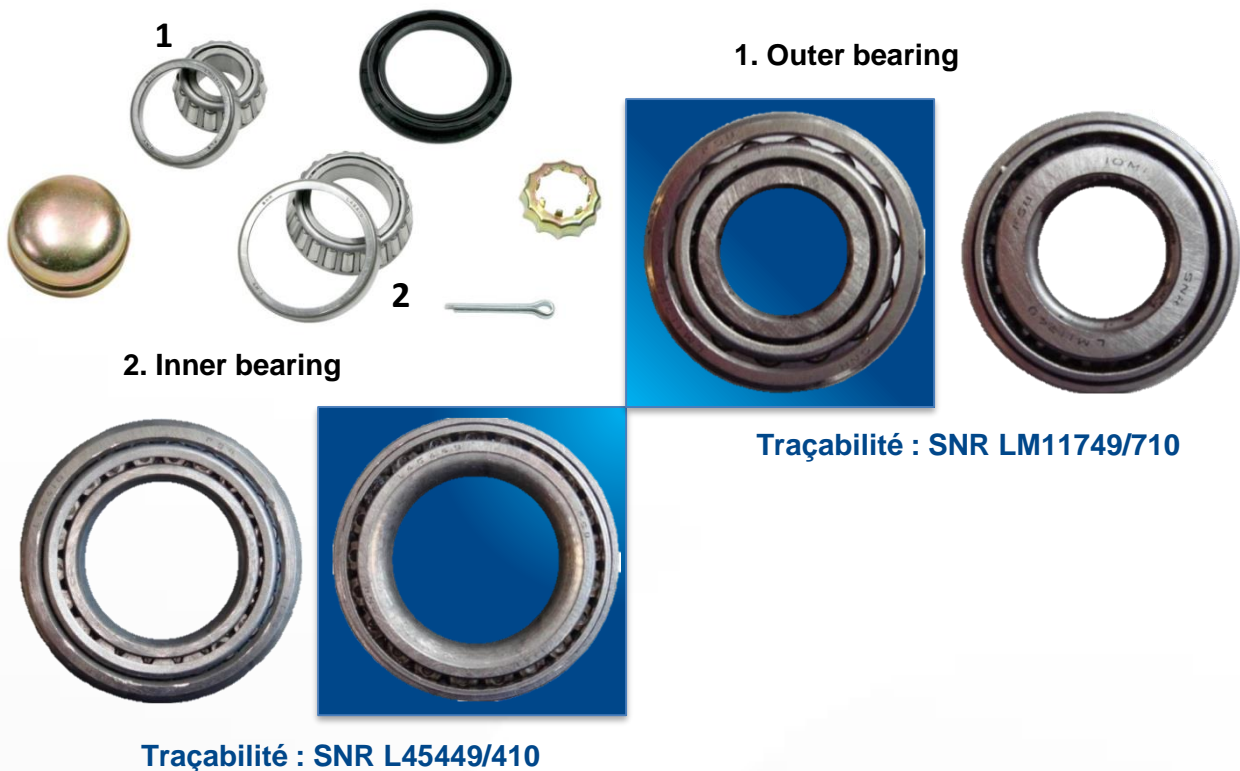
<b>AUDI :</b>	50, 80 (81, 89-8A), 90 (81, 85, 89,8A), Coupé 85	<b>OE reference</b> 191598625, 6U0598625
<b>SEAT :</b>	Arosa, Cordoba (I and II), Ibiza (II and II FL1), Toledo series 1	
<b>SKODA :</b>	Favorit, Felicia, Felicia FL, Forman	
<b>VOLKSWAGEN :</b>	Caddy II, Coccinelle/Beetle, Corrado, Derby, Golf (I, II and III), Fox, Jetta (I and II), Passat (I, II, III and IV), Polo (I, II, III, IV and V), Santana, Scirocco, Vento, Golf Cabriolet (Golf I, II and III)

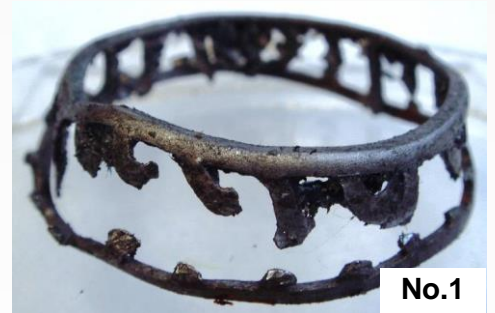
### Over-tightening of the stub axle bolt.

This raises the temperature inside the bearing, breaks down the grease in contact with the rolling elements and causes spalling damage to the raceways.

As a result, the bearing seizes, causing the cage to break up (**no. 1**) and destroy the bearing.

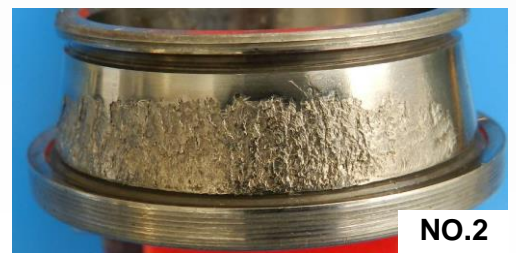
### Operation with a bent stub axle.

This problem can occur due to wear or by over tightening of the stub axle nut.

As a result the seating of the inner rings on the stub axle is changed, which leads to spalling (**no. 2**) and bearing failure.

It is essential to inspect the stub axle and replace it if it is bent or damaged in any way, failure to do so will lead to a rapid failure of the newly fitted bearing.

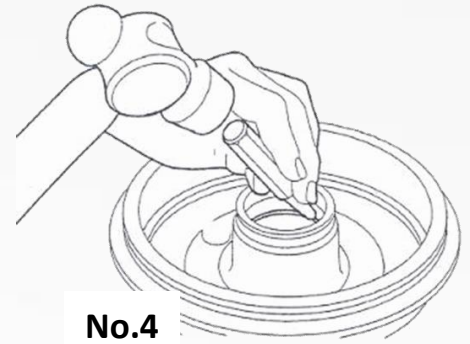
8) Extract the inner and outer bearing cups (no. 4)
