R166.03

Disassembly / Assembly recommendations

| <p>CITROËN: C2, C3, C3 II, C3 Pluriel, C4 Cactus, C Elysée, DS3</p> <p>PEUGEOT: 207, 207+, 208, 301, 1007, 2008</p> | <p>OE reference 3350/-86</p> |

IDENTIFICATION OF WHEEL BEARING KIT R166.03

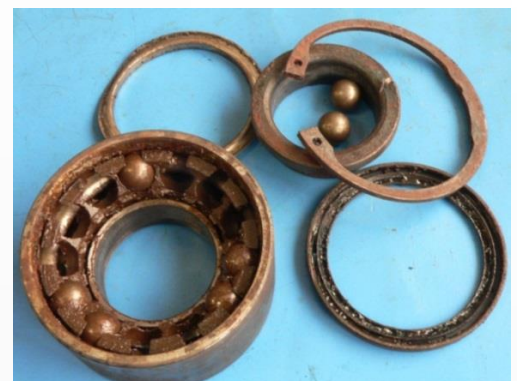
no.1

Corroded bearing

- Incorrect installation – if the bearing is not tightened to the correct torque, the rolling elements can push the seal outwards allowing water to enter the bearing. **(no.1)**
- If the encoder seal is damaged during installation of the bearing it may lead to water ingress causing corrosion inside the bearing

Carefully follow the fitment instructions, only use the correct tools for this job and make sure all the new parts supplied in the kit are fitted.

Follow the vehicle manufacturer's installation procedures and only apply the specified tightening torques.

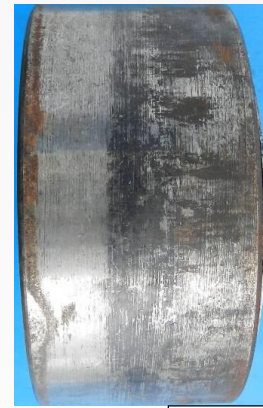
no.2

Worn bearing

- Incorrect tightening of the transmission nut, leads to premature wear of the outer circumference of the bearing. **(no.2)**
Tightening torque specifications for the transmission nut are: **245 ±5 Nm**
- Incorrect installation can also cause abnormal wear to the bearings raceways. **(no.3)**
- Impacts such as kerb strikes can generate cracks and fissures on the raceways, this normally causes the bearing to fail prematurely.
