GENERAL RECOMMENDATIONS

1 FLANGE INDENTATIONS OR FRACTURES

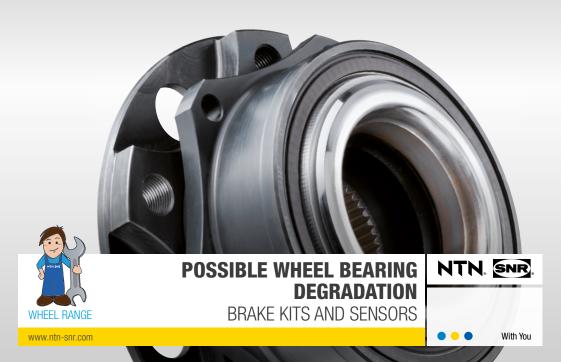
- 1 Flange indentations or fractures
- 2 Scratches on the balls
- 3 Spalling
- 4 Fatigue spalling
- **5** Seizing / overheating / lubrication failures
- 6 Grease leakage
- 7 Vibrations
- 8 Loss of steering precision
- 9 "Clack" noise
- 10 ABS malfunctions
