BRAKE KITS AND SENSORS

GENERAL RECOMMENDATIONS

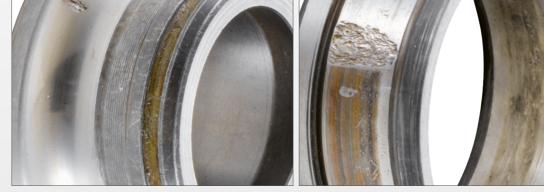
FATIGUE SPALLING

CAUSES Fatigue

- Incorrect installation Incorrect geometry of a neighboring parts

EFFECTS Removal of material by flaking

along the raceway

- When installing the bearing:
- Follow the general recommendations associated with the installation • Be sure to check the condition of the mating surfaces of the hub or
- stub axle and of the kingpin (no cracks or wear)

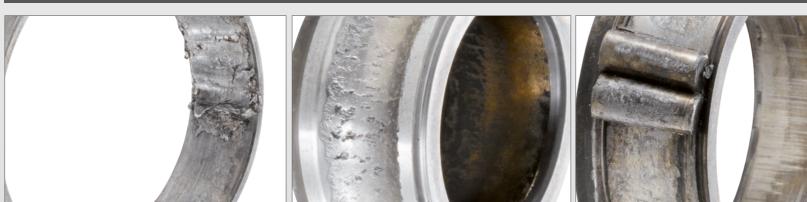
SEIZING / OVERHEATING / LUBRICATION FAILURES

CAUSES

- Lack of lubrication or inappropriate lubrication
- Micro-welds between the bearing
- components • "Mixed" grease following ingress of contaminants

EFFECTS

- Shallow metal pullouts on the bearing raceway
- Welding of the bearing components • Discoloration of components

- When installing the bearing:
- Monitor for abnormal grease leakage
- Follow the general recommendations associated with the installation • Make sure bearing elements have correct lubrication

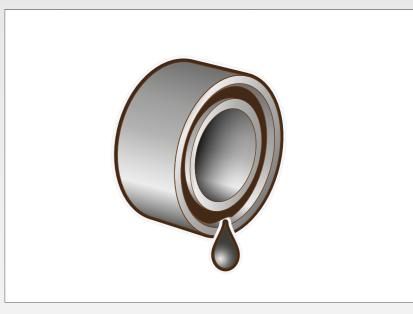
GREASE LEAKS

• Extremely high bearing temperature, causing grease to deteriorate • Damage of sealing systems during installation (seals)

EFFECTS

- Water ingress in the bearing
- Evidence of grease leaking from the bearing seals

- When installing the bearing:
- Verify that there is no overheating problem Check bearing seal integrity

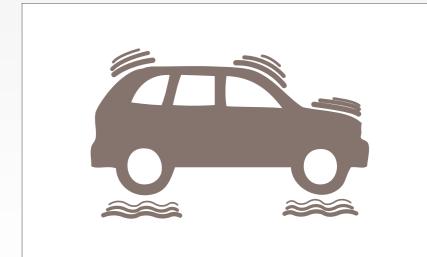
VIBRATIONS

• Poor condition of neighboring parts (spalling problem)

EFFECTS

Loose bearing

• Risk of bearing damage (spalling, scratches on the balls)

• Vibrations felt in the steering wheel or in the passenger compartment, while driving

RECOMMENDATIONS Check wheel balancing and good condition of tyres

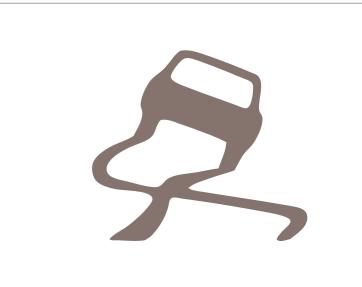
LOSS OF STEERING PRECISION

• Rigidity problem of the car's front axle suspension or worn suspension bush

- Incorrect geometry adjustment of the car's front axle
- Loose bearing

EFFECTS

- On straight line, the vehicle tends to go to the right or to the left
- Risk of bearing damage (spalling, scratches on the balls)

- · Check running gear geometry
- Replace the worn ball joints or suspension bush Follow the general recommendations associated with the

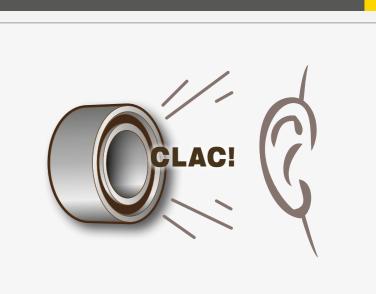
CLACK NOISE

Bearing deterioration

• Slight displacement of the bearing in the stub axle

EFFECTS • Clack noise in the front suspension (during parking maneuvers)

When installing the bearing:
