SUSPENSION range

POSSIBLE DEGRADATION OF STRUT BEARINGS AND STRUT DAMPING BLOCK

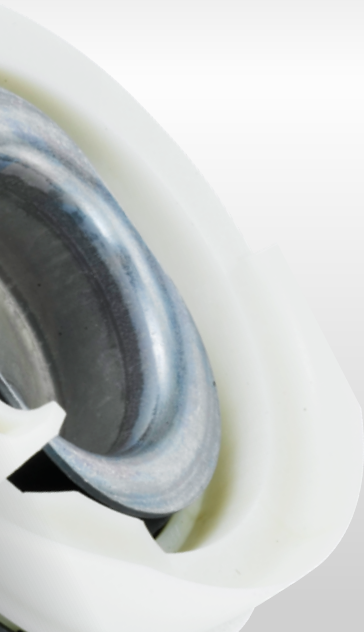
1 Corrosion

2 Fracture

3 False brinelling effect (FBE)

4 Tearing of the strut damping block

5 Material Damage

6 Inverted installation
