WHEEL RANGE

www.ntn-snr.com

POSSIBLE WHEEL BEARING DEGRADATION

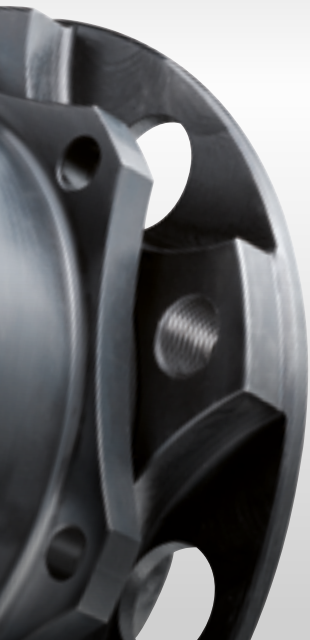
- 1 Flange indentations or fractures**
- 2 Scratches on the balls**
- 3 Water ingress due to a sealing failure**
- 4 Fatigue spalling**
- 5 Seizing / overheating / lubrication failures**
- 6 Grease leakage**
- 7 Vibrations**
- 8 Loss of steering precision**
- 9 “Clack” noise**
- 10 ABS malfunctions**

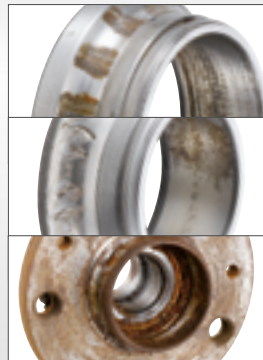
3 WATER INGRESS DUE TO A SEALING FAILURE

Water Ingress:

- Inappropriate use of the vehicle.
- Missing baffle sealing element
- Deterioration of bearing seal during maintenance
- Missing cap or failure to replace cap

EFFECTS

- Localized or generalized oxidation of the bearing
- More-or-less extensive reddish or black stains
- Surface attacked by more-or-less deep pitting
- Reproduction of indentations on the raceway

- Do not disassemble a sealed bearing
- Avoid splashing liquids
- Follow the general recommendations associated with the installation
- Replace all parts supplied in the NTN-SNR kits

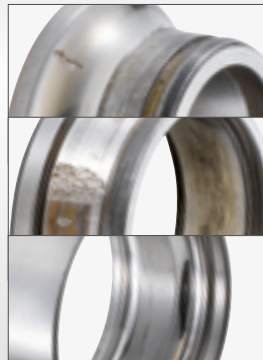
4 FATIGUE SPALLING

- Fatigue
- Incorrect installation
- Incorrect geometry of a neighboring part

- Removal of material by flaking along the raceway

- Follow the general recommendations associated with the installation
- Be sure to check the condition of the mating surfaces of the hub or stub axle and of the kingpin (no cracks or wear)

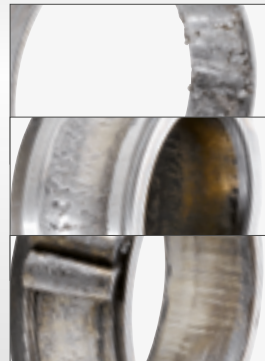
5 SEIZING / OVERHEATING / LUBRICATION FAILURES

- Lack of lubrication or inappropriate lubrication
- Micro-welds between the bearing components
- “Mixed” grease following ingress of contaminants

- Shallow metal pullouts on the bearing raceway
- Welding of the bearing components
- Discoloration of components

- Monitor for abnormal grease leakage
- Follow the general recommendations associated with the installation
- Make sure bearing elements have correct lubrication
