Brand of **NTN** corporation

POSSIBLE WHEEL BEARING DEGRADATION

WHEEL
RANGE

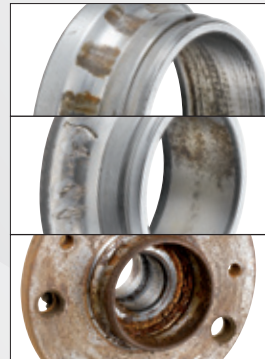
3 WATER INGRESS DUE TO A SEALING FAILURE

CAUSES

Water Ingress:

- Inappropriate use of the vehicle.
- Missing baffle sealing element
- Deterioration of bearing seal during maintenance
- Missing cap or failure to replace cap

EFFECTS

- Localized or generalized oxidation of the bearing
- More-or-less extensive reddish or black stains
- Surface attacked by more-or-less deep pitting
- Reproduction of indentations on the raceway

RECOMMENDATIONS

When installing the bearing:

- Do not disassemble a sealed bearing
- Avoid splashing liquids
- Follow the general recommendations associated with the installation
- Replace all parts supplied in the SNR kits

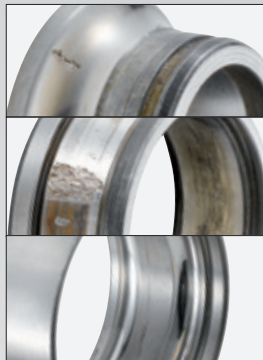
4 FATIGUE SPALLING

CAUSES

- Fatigue
- Incorrect installation
- Incorrect geometry of a neighboring part

EFFECTS

- Removal of material by flaking along the raceway

RECOMMENDATIONS

When installing the bearing:

- Follow the general recommendations associated with the installation
- Be sure to check the condition of the mating surfaces of the hub or stub axle and of the kingpin (no cracks or wear)

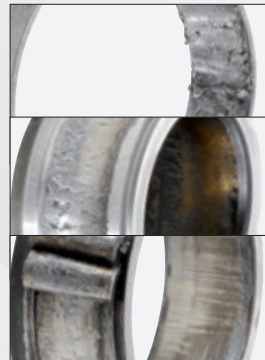
5 SEIZING / OVERHEATING / LUBRICATION FAILURES

CAUSES

- Lack of lubrication or inappropriate lubrication
- Micro-welds between the bearing components
- “Mixed” grease following ingress of contaminants

EFFECTS

- Shallow metal pullouts on the bearing raceway
- Welding of the bearing components
- Discoloration of components

RECOMMENDATIONS

When installing the bearing:

- Monitor for abnormal grease leakage
- Follow the general recommendations associated with the installation
- Make sure bearing elements have correct lubrication
