POSSIBLE DEGRADATION OF STRUT BEARINGS

AND STRUT DAMPING BLOCK

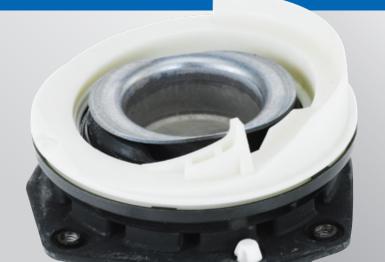
A	
	1

- 1	Corrosion
2	Fracture
3	False brinelling effect (FBE)
4	Tearing of the strut damping block
5	Material Damage
6	Inverted installation1
