# POSSIBLE WHEEL BEARING DEGRADATION

## BRAKE KITS AND SENSORS

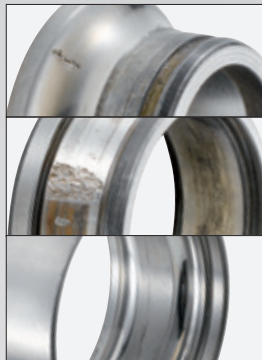
## 4 FATIGUE SPALLING

- Fatigue
- Incorrect installation
- Incorrect geometry of a neighboring part

- Removal of material by flaking along the raceway

- Follow the general recommendations associated with the installation
- Be sure to check the condition of the mating surfaces of the hub or stub axle and of the kingpin (no cracks or wear)

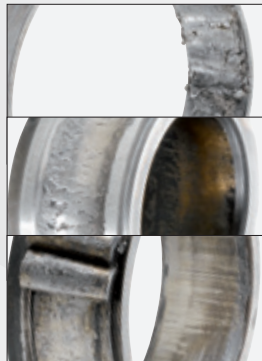
## 5 SEIZING / OVERHEATING / LUBRICATION FAILURES

- Lack of lubrication or inappropriate lubrication
- Micro-welds between the bearing components
- “Mixed” grease following ingress of contaminants

- Shallow metal pullouts on the bearing raceway
- Welding of the bearing components
- Discoloration of components

- Monitor for abnormal grease leakage
- Follow the general recommendations associated with the installation
- Make sure bearing elements have correct lubrication
