GA357.09/GB-07/2022

# GA357.09

## Assembly/disassembly recommendations

### IDENTIFY ROLLER TENSIONER GA357.09

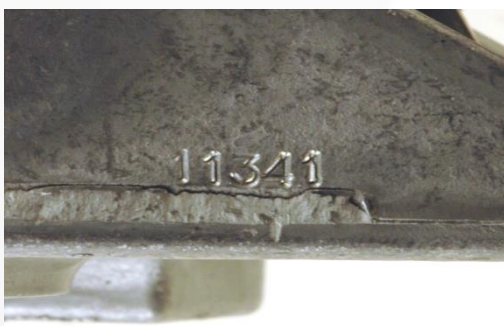
Traceability

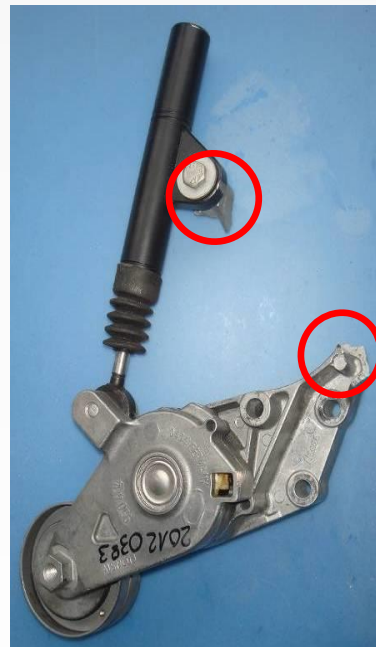
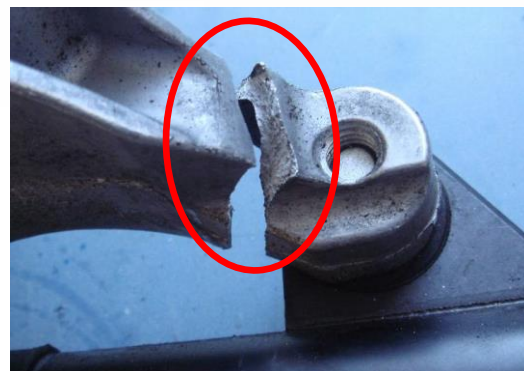
### PROBLEMS WITH BREAKAGE OF ALUMINUM SUPPORT

A worn over-running freewheel alternator pulley. Thus, the freewheel alternator pulley is no longer overrunning, resulting in strong acyclic motion in the belt.

All this leads to abnormal vibrations from the belt. The GA357.09 is not designed to absorb violent shocks from the belt, the aluminum support is thus liable to fail after a certain operating period. This can even lead to the destruction of the bearing.

The belt has been ejected from the grooves of the various pulleys, resulting in a misalignment. It is thus out of alignment. Such a phenomenon is related to strong acyclic movements in the belt.

- GA357.09 related failures are a result of incorrect operation of the over-running alternator pulley, which is faulty and was not replaced at the same time as the roller tensioner.
- The resulting breakdown of the entire accessory drive leads to vehicle immobilization.

- It is best to replace the over-running freewheel alternator pulley at the same time as the belt to avoid premature failure (a breakdown in the over-running freewheel alternator pulley leads to other engine issues). To find the reference for your application, refer to the NTN-SNR "Accessories" catalog.
- Use suitable equipment to loosen and remove a pulley on the alternator and to ensure the correct performance of the system.
- Check the condition of your pulley as a pulley failure can cause breakage of the roller bearing.

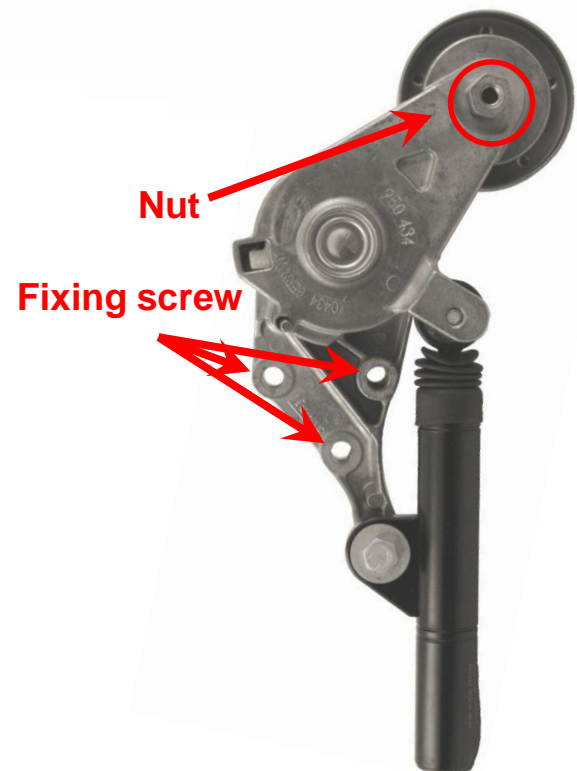
- 1) Remove the engine undertray
- 2) Remove parts to access the roller
- 3) Move the roller tensioner with a spanner in a clockwise direction
- 4) Remove the accessory drive belt

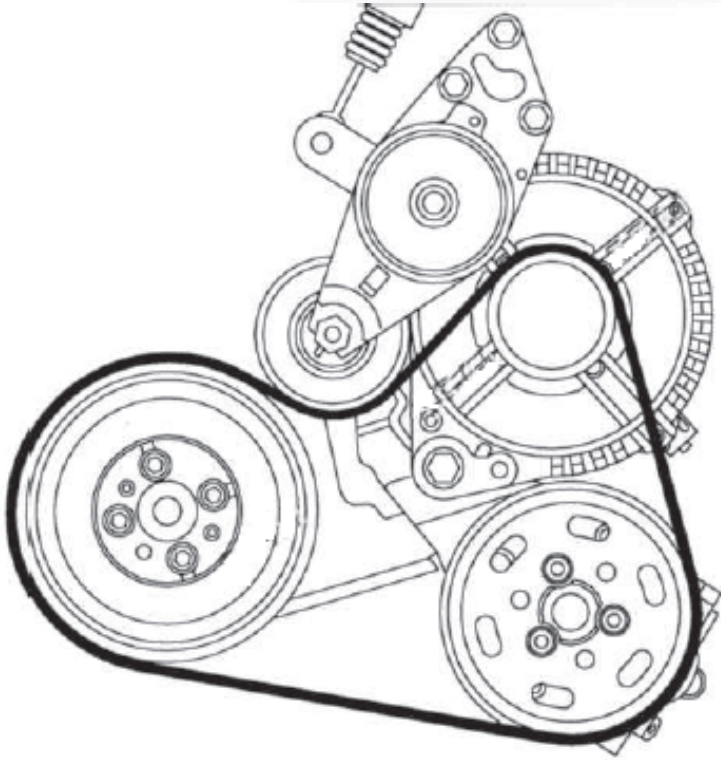
**Routing the accessory belt  
(vehicle without air conditioning)**

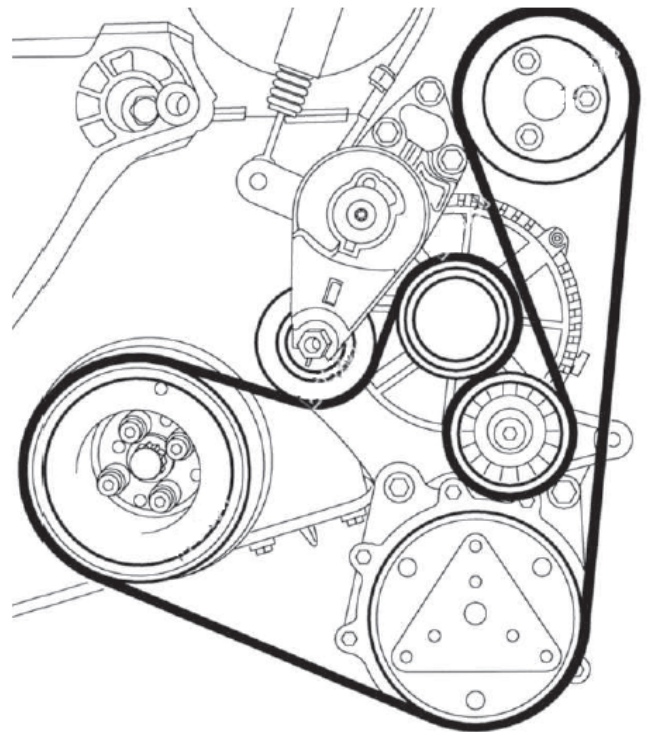
**Routing the accessory belt  
(vehicle with air conditioning)**

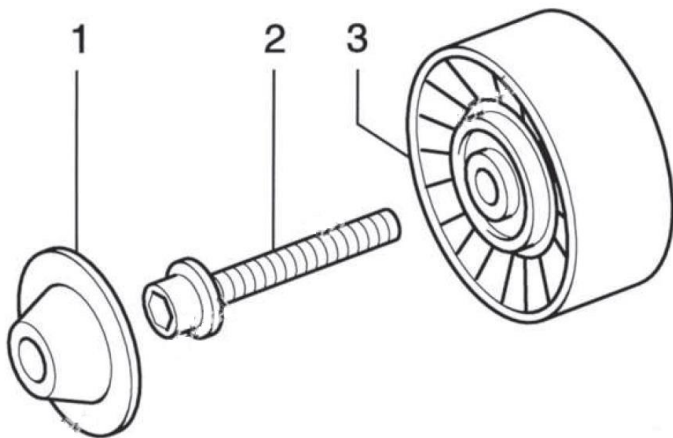
**Installing the belt guide roller  
(Ref. NTN-SNR GA357.06)  
(only for vehicles with air conditioning)**
