NTN

DIAGNOSTICS

Bearing failures

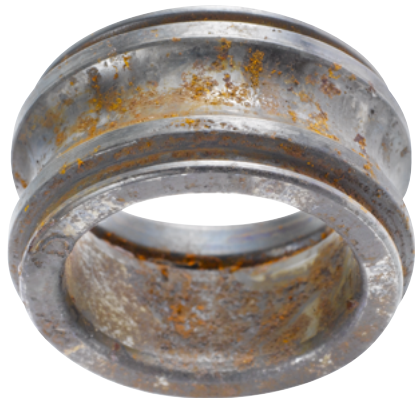
1 Corrosion by oxidation

- Marks or pits

- Pollution by water, old oil, hydraulic fluid or aggressive additives

- Purge the bearings and remove the old lubricants
- Avoid water contacting the bearings

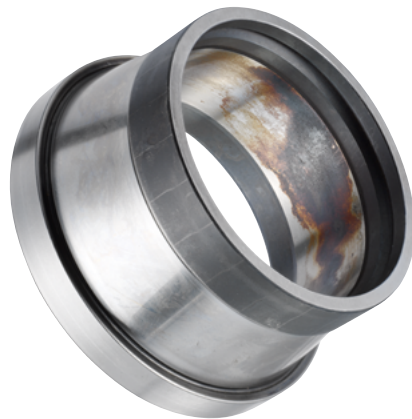
2 Fretting corrosion

- Oxide layer on the outer surfaces of the bearing

- Microscopic displacement between ring and support

- Check the precision and seat adjustments
- Use NTN-SNR anti-fretting paste and an induction heater to install the bearing on the shaft

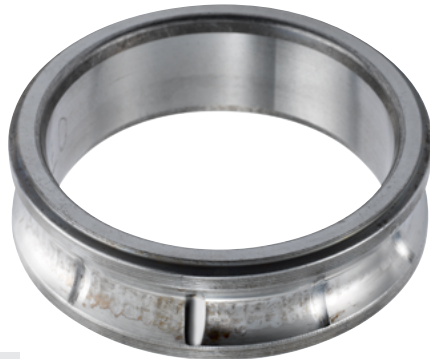
3 False brinelling

- Corrosion due to friction between rolling elements and raceways

- In the static state, vibrations or oscillations shear the oil film

- Avoid storing stationary rotating machines near sources of vibration such as a compressor or vibrating unit
- The bearings must be stored flat

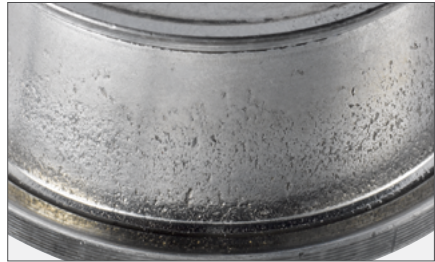
4 Surface spalling initiated at the surface (ÉSIS)

- Surface spalling initiated at the surface

- Inadequate lubrication (quantity/quality)
- Rupture of the oil film
- Presence of small, very fine and hard particles

- Check the temperature level
- Choose a suitable lubricant (quantity and viscosity) as well as an automatic lubrication system
- Avoid the intrusion of solid particles and liquids during and after mounting

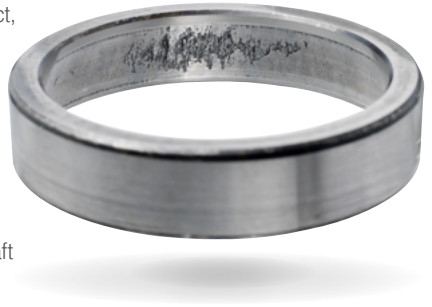
5 DEEP spalling initiated at a depth (ÉPIS)

- Spalling initiated on a surface defect (indentation, impact, corrosion, excess stress, etc.)

- Solid contamination
- Impact
- Entry of corrosive liquid
- Misalignment or deformation of the housing or the shaft

- Avoid introducing contaminants when mounting
- Control the geometry and quality of seats to avoid stresses due to misalignment in the bearings

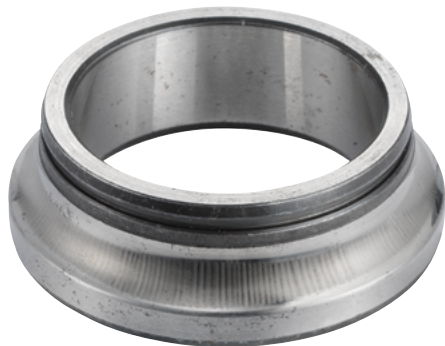
7 Electro-erosion

- Piqûres ou cannelures

- An electric current passing through a bearing

- Make sure electric currents do not pass through the bearing. For generator and electric motor applications, choose NTN MEGAOHM insulated bearings

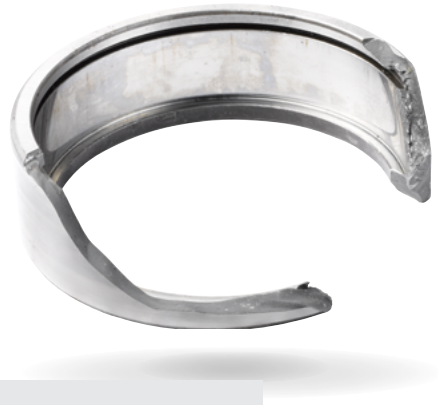
9 Rupture

- Ring rupture

- Shocks, overload, bending force, fatigue or thermal overstresses

- Never strike a bearing directly with a hammer
- Check the condition of the seats before mounting
- Use the correct mounting method and suitable tools
- Quickly replace a noisy bearing

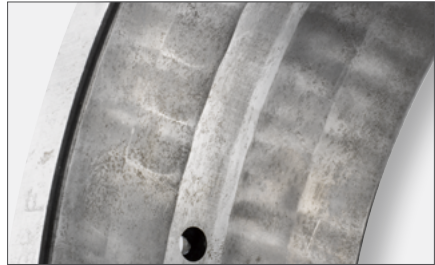
10 Wear under the action of particles

- Matt surface, streaks or pits on rolling housings and raceways

- Solid particle abrasion in boundary lubrication

- Choose a sealing device that is effective against the penetration of solid particles (seals, shields)
- Make sure to use a clean lubricant for maintenance
- Use a lubricant

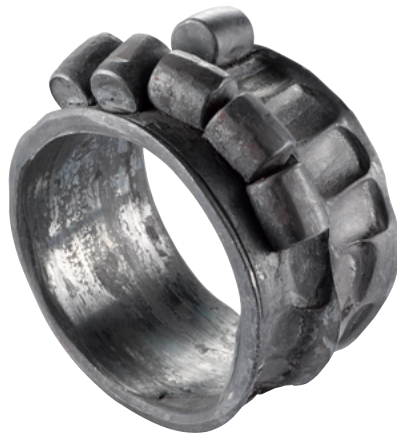
11 Wear by friction

- Metal elements welded to one another

- Significant sliding due to temperature rise

- Use a suitable lubricant in terms of quantity and quality and a suitable bearing in terms of load and speed

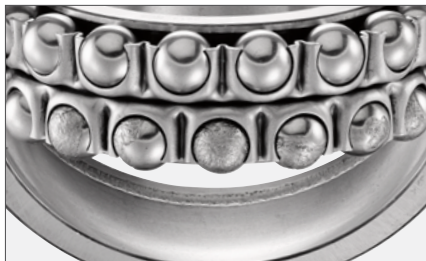
12 Spalling by axial overload

- Presence of spalling on one side of the bearing raceways

- Excessive axial load

- Check the floating bearing is free to move
