GA354.12/GB-07/2022

# GA354.12

## Assembly/disassembly recommendations

## IDENTIFICATION OF BELT TENSIONER ROLLER GA354.12

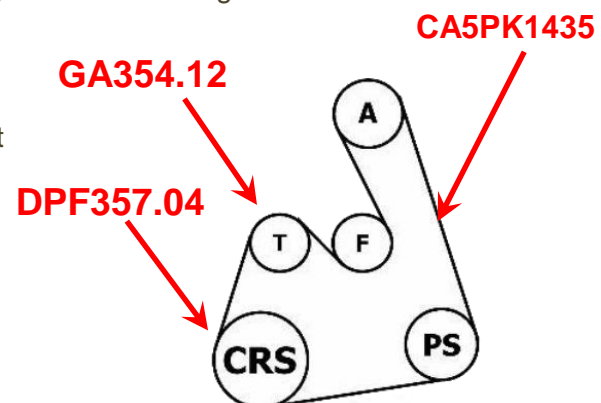
**Special tools** - Tensioner roller wrench: OE 303-676

- 1) Loosen the pulley by turning it anticlockwise using an appropriate tool (Fig 1 and 2)
- 2) Remove the belt (Fig 3)
- 3) Remove the tensioner roller bolts
- 4) Remove the tensioner roller
