## GA359.70

### Assembly/disassembly recommendations

### IDENTIFICATION OF ACCESSORY BELT TENSIONER ROLLER

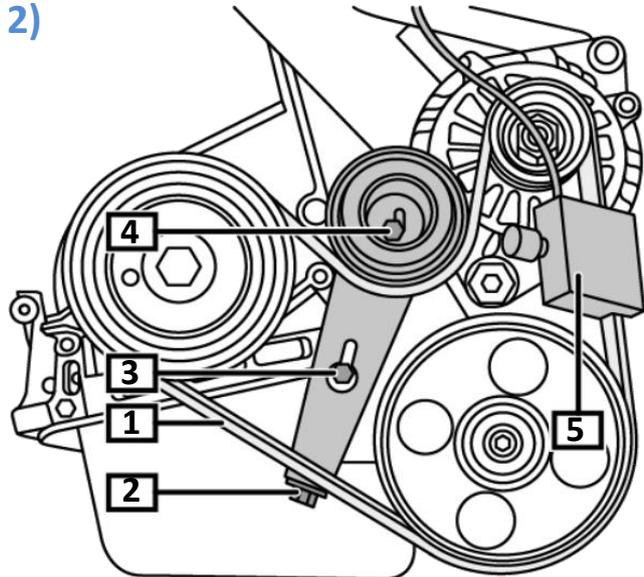
- 1) Remove the right front wheel
- 2) Remove the wheel well cover
- 3) Loosen the tensioner roller bolt(s) (Fig 3 and 4)
- 4) Tighten the bolt(s) to the limit (Fig 2)
- 5) Remove the belt (Fig 1)
