KD457.48

Disassembly/ Assembly recommendations

AUDI:	A4 (Series 2, 2 FL, Cabriolet), A6 (Series 2, 2FL, Allroad), A8	ENGINES	OE reference
SKODA:	Superb	2.5TDi	[059109119B + 059109243J + 059109243L + 059109244B + 059109479B + 059109487C + 0591130113A]
VOLKSWAGEN:	Passat

TIMING BELT DIAGRAM FOR KIT KD457.48

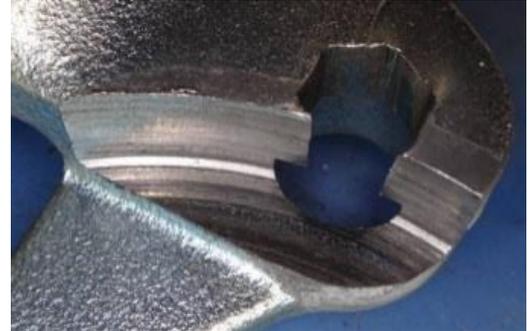
Incorrect installation of GT357.31

This roller requires a particular installation procedure.

The retaining bolt must be fully seated against the washer once the specified tightening torque has been applied. If the bolt is tightened incorrectly or not positioned correctly, it will snap, GT357.31 will then rub against GT357.53 causing damage.

Abrasion mark caused by roller contact

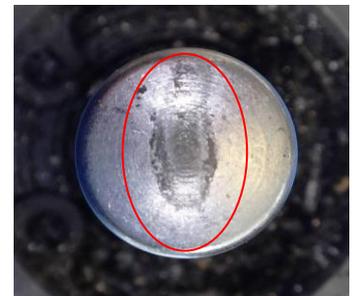
Incorrect tension of GT357.31

- Misalignment of the hole in the shaft of the tensioner and the body of the tensioner indicate a problem with the tension.

Contact mark

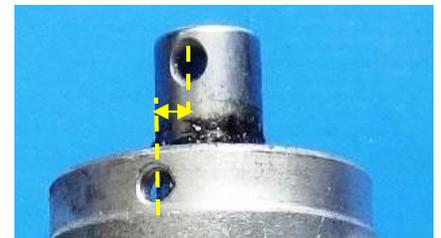
This defect will also cause misalignment and abrasion of the belt.

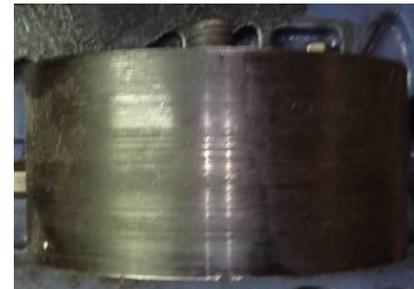
Overheating of GE357.30

Tensioner roller installation specifications (see pages 5 and 6) must be followed carefully. Failure to do so may cause misalignment, loss of belt teeth or even overheating due to rubbing.

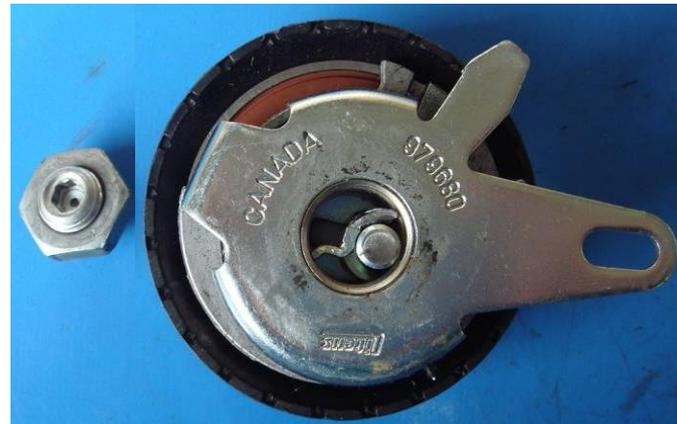
Incorrect installation of GT357.28

Tool OE (3078) is used to tighten the retaining bolt on GT357.28 an Allen key inserted in the tool is used to adjust the eccentric cam that sets the tension applied by the roller. (See page 7) Incorrect installation can cause the roller's shaft to break or result in incorrect belt tension.

Roller GT357.28 with broken shaft

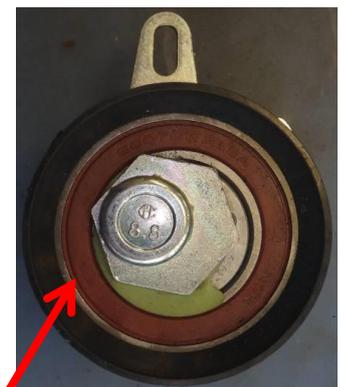
Incorrect tightening of GT357.28

If the retaining bolt has not been tightened correctly using the correct torque setting, the correct tools, or the washer has been left off or incorrectly installed, the lower stop marker will to move backwards and forwards too much and hit the stops this leaves damage on both stops. If the tensioner is correctly adjusted the lower marker will never hit the stops.

The 6 faces underneath GT357.28 are not involved in the operation of the roller. Never tighten or loosen it.

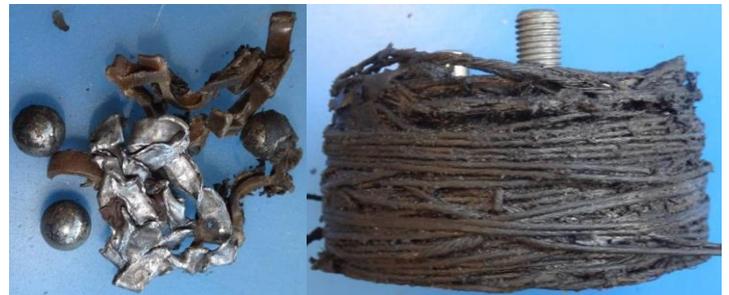
Component seizure

A seized component will cause the belt to overheat, due to friction caused by the belt slipping over the seized component this then causes other components to overheat and break up (bearing grease, rollers, casing).

Consequences of belt slippage

The most common cause of this failure is a water pump seizure. It is recommended that the water pump is changed when a timing belt is replaced.
