# POSSIBLE DEGRADATION OF STRUT BEARINGS AND STRUT DAMPING BLOCK

SUSPENSION  
RANGE

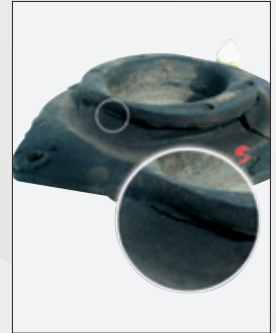
## 5 MATERIAL DAMAGE

- Reduced comfort

- Extreme weather conditions (very low or very high temperatures)
- Chemical contamination (brake fluid, oil, etc.)

- Reduced product service life due to material damage

- Determination of the cause and repair by replacement of damaged strut damping block

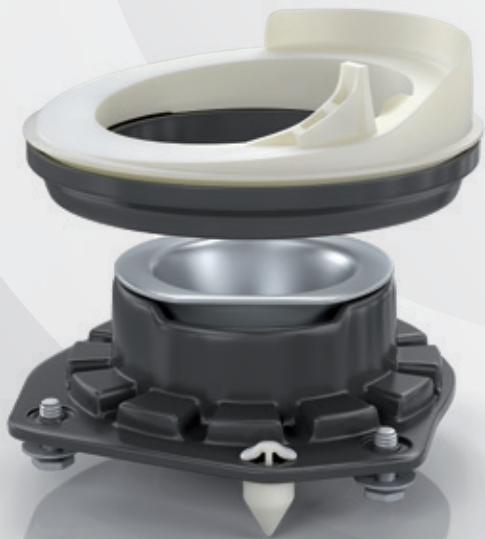
## 6 INVERTED INSTALLATION

- Increased torque
- Risk of parasitic noise

- The strut bearing was not installed in the correct orientation

- Damage of the strut bearing
- Damage of the strut damping block
- Possible failure to pass motor vehicle inspection

- Carefully follow the correct order and orientation of each component make and make ensure no parts are missing.
