# CVJ BOOTS

## Possible causes of damage

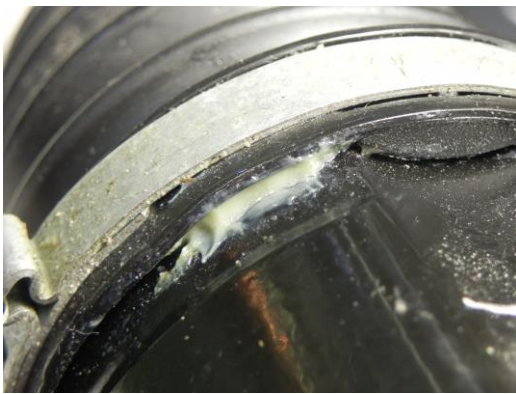
- Grease leakage
- Presence of grease under the clamp

- 1- Bad clamping
- 2- Bad clamp or bad boot position

The manufacturers fitting instructions and specified torque setting should always be followed. The correct tools should always be used for the removal and fitment process.

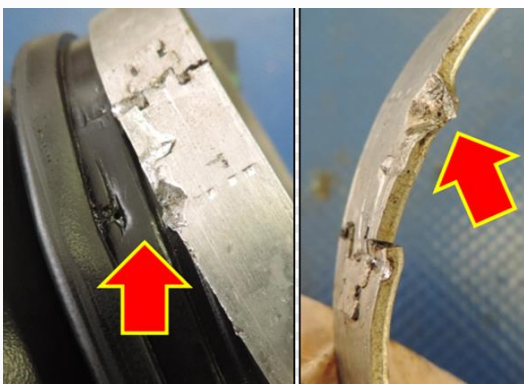
### 3- Tear Boot

- 4- Shock on the boot clamp

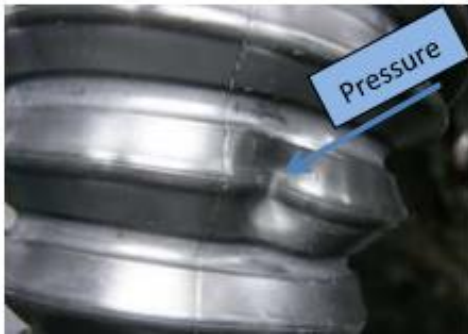
## - Boot reversion

Causes :

- 1- Bad handling
- 2- External damage / aggression
- 3- Strong pressure on the boot
